T2 Laboratories Explosion Damage Assessment

Presenter: Ben Harrison, P.E., ABS Consulting, 14607 San Pedro Suite 215, San Antonio, TX, 78232, phone (210) 495-5195, fax (210) 495-5134, bharrison@absconsulting.com

The CSB approved this paper for release and presentation at the 2010 DDESB Explosives Safety Seminar.

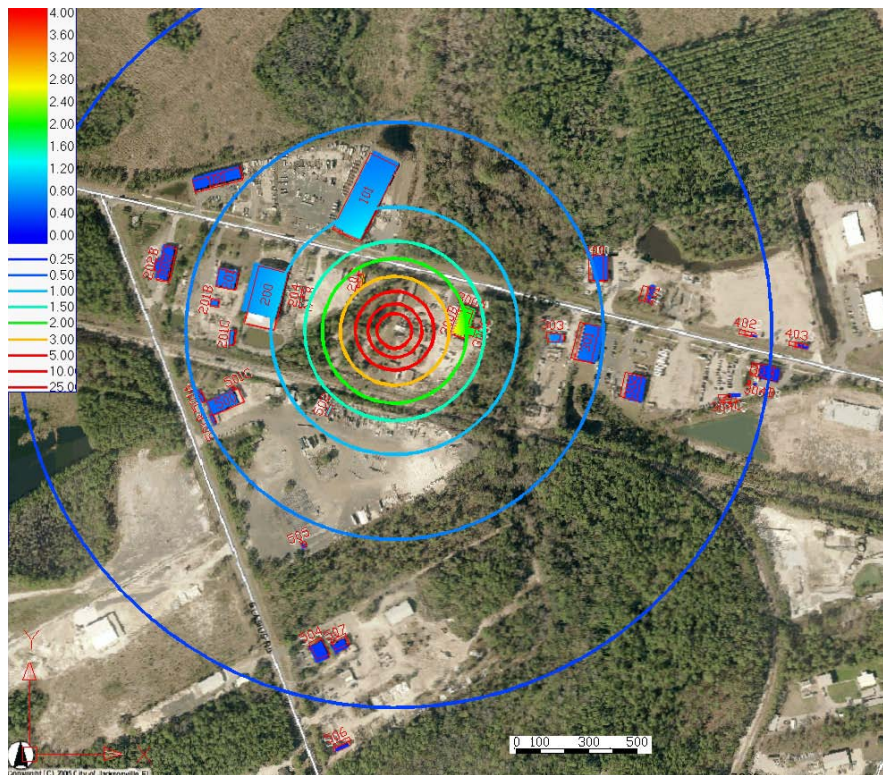
Figure 8. Free-Field Pressure Contours for Estimated TNT Yield of Explosion

The estimated TNT yield of the December 19 explosion at T2 Laboratories was obtained by averaging the estimated yields obtained from each data set and was determined to be approximately 1,400 lb_{TNT} as shown below in Table 2. Free field pressure and impulse contours are provided in Figure 8 and Figure 9 respectively.

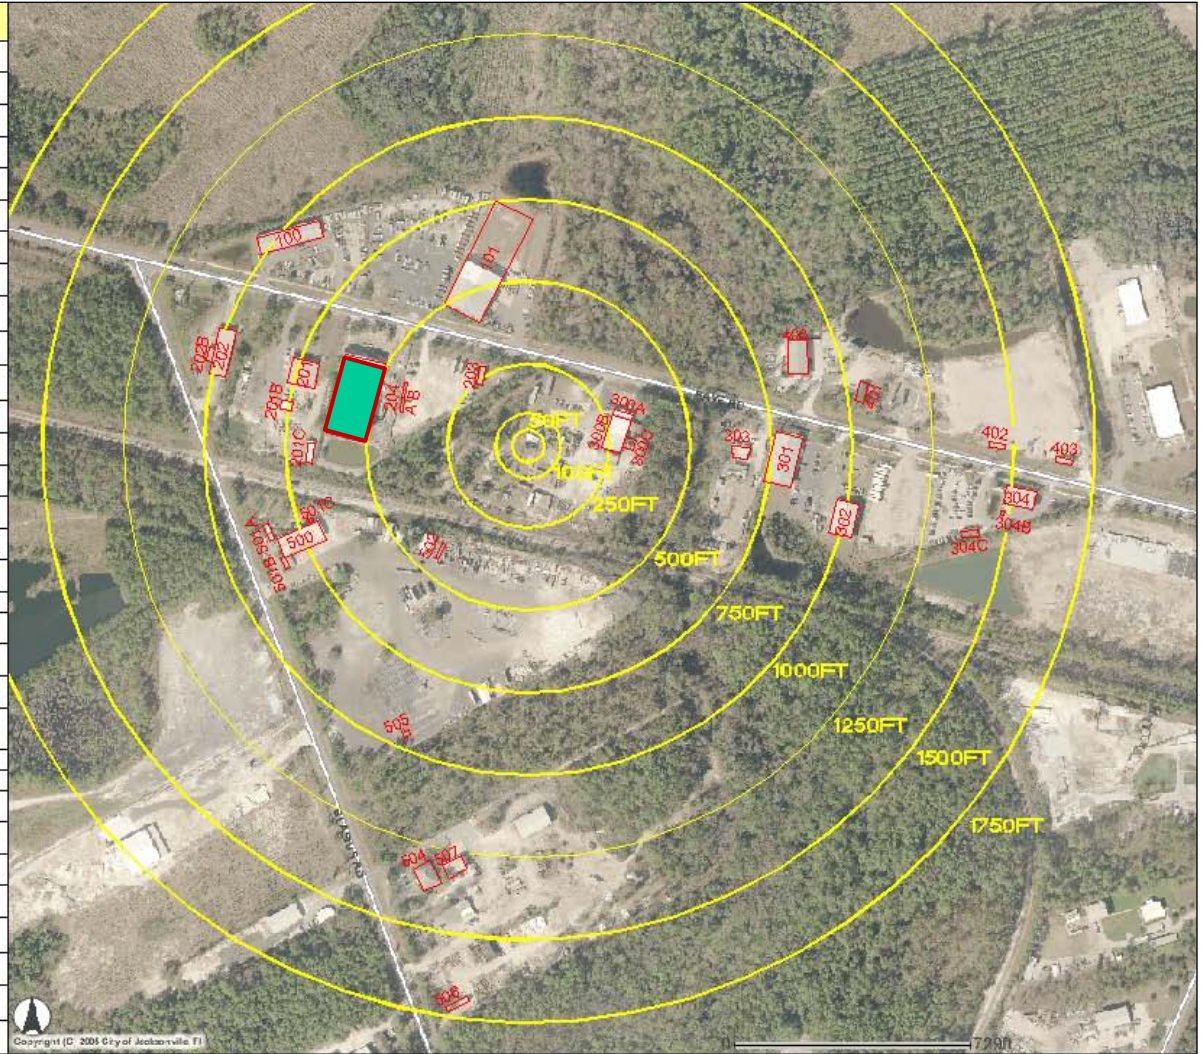
Example Building Damage Building 200 (K50)

the potential exists to cause structural damage well beyond K40 separation. Two large pre-engineered warehouses (Buildings 101 and 200) located at K50 were condemned as a result of the explosion.
